## **An Approach to Adapting Historical Buildings to Reuse: The Case of Kostaki Mansion in Trabzon**

Ayşe Esin Kuleli\*

**Cite as/ Atıf:** Kuleli, A. E. (2022). An approach to adapting historical buildings to reuse: The case of Kostaki Mansion in Trabzon. *Turkish Studies*, 17(2), 367-396. <https://dx.doi.org/10.7827/TurkishStudies.57596>

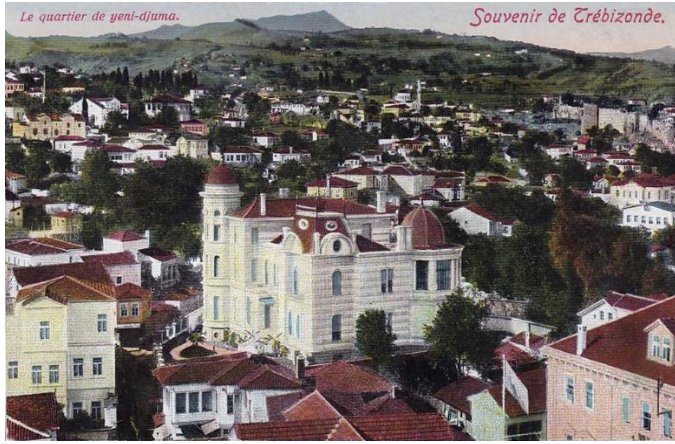
**Figure 2:** Historical urban texture around Kostaki mansion (First half of 20th century).  
[https://commons.wikimedia.org/w/index.php?title=Category:Postcards\\_of\\_Trabzon&fileuntil=Walls+of+the+ancient+city%2C+Trebizond.jpg#/media/File:Trebizonde\\_-\\_Yeni-Cuma\\_quarter\\_colour.jpg](https://commons.wikimedia.org/w/index.php?title=Category:Postcards_of_Trabzon&fileuntil=Walls+of+the+ancient+city%2C+Trebizond.jpg#/media/File:Trebizonde_-_Yeni-Cuma_quarter_colour.jpg) (Access Date. 18.01.2021).

Trabzon, which preserved its historical urban texture until the 1960s, was unfortunately damaged by multi-storey and irregular structuring approach after those years (Karpuz, 1996, p. 126). Neglection towards the houses in the historical urban texture, the wrong decisions, caused the buildings to destroy gradually. The same things can be said for the buildings taken place on Zeytinlik Street and Kasım Street, on which Kostaki Mansion is located. From the examination of an old photograph that is thought to belong to the early 20th century, a texture consisting of two or three-storey historical buildings is perceived in the vicinity of the Kostaki mansion. Also it can be understood that the Kostaki Mansion had a dominant location in the city (Fig. 2).

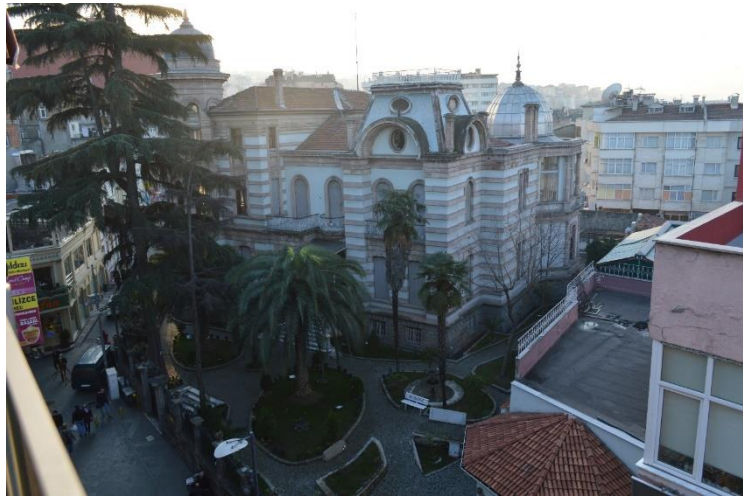
**Figure 3:** Irregular structures around Kostaki mansion Uzun Street (Kuleli, 2013).

It is seen that multi-storey reinforced concrete buildings, which were planned without worrying about adaptation to the texture, were built near past. It is really hard to find Kostaki mansion among those irregular structures built around it (Fig. 3).

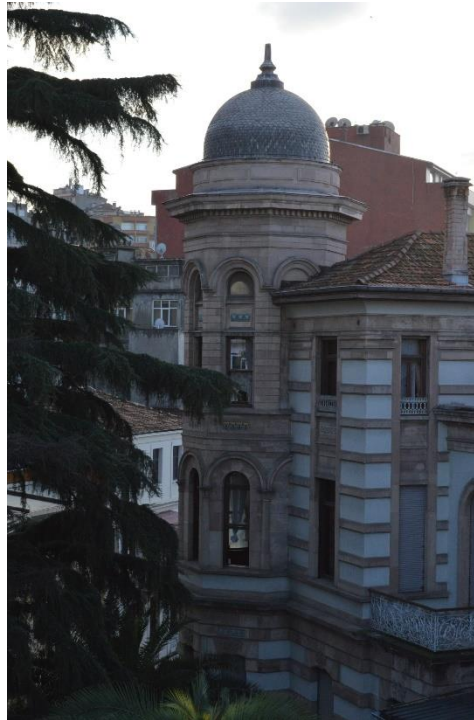
**Figure 4:** The domed tower on the eastern facade of the mansion (Kuleli, 2013).

Domed towers were used in the southeast and northwest corners of the building. It is stated that the Greek-origin Kostaki Teophylaktov, who built the building, was one of the leading bankers, and traders of Trabzon. Due to Kostaki's commercial relations with Russia, Russian architecture may have affected the architectural form of the building (Erten, 1989, p. 87).

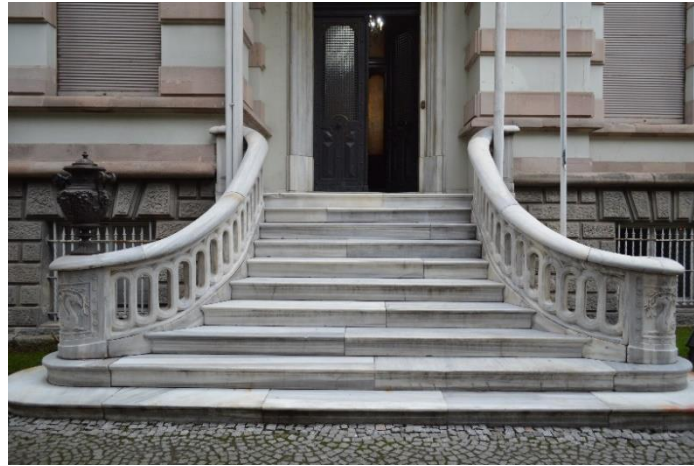
**Figure 5:** Main entrance to the mansion (Kuleli, 2013).

Special attention was paid to the entrance design of the mansion, and the use of marble was preferred for the stairs and balustrades ending with spiral curves on the sides (Fig. 5, 6). On the eastern facade of the entrance to the mansion, a balcony was designed and the empirical and baroque-style spiral fold branches and leaves on the balcony balustrades were used.

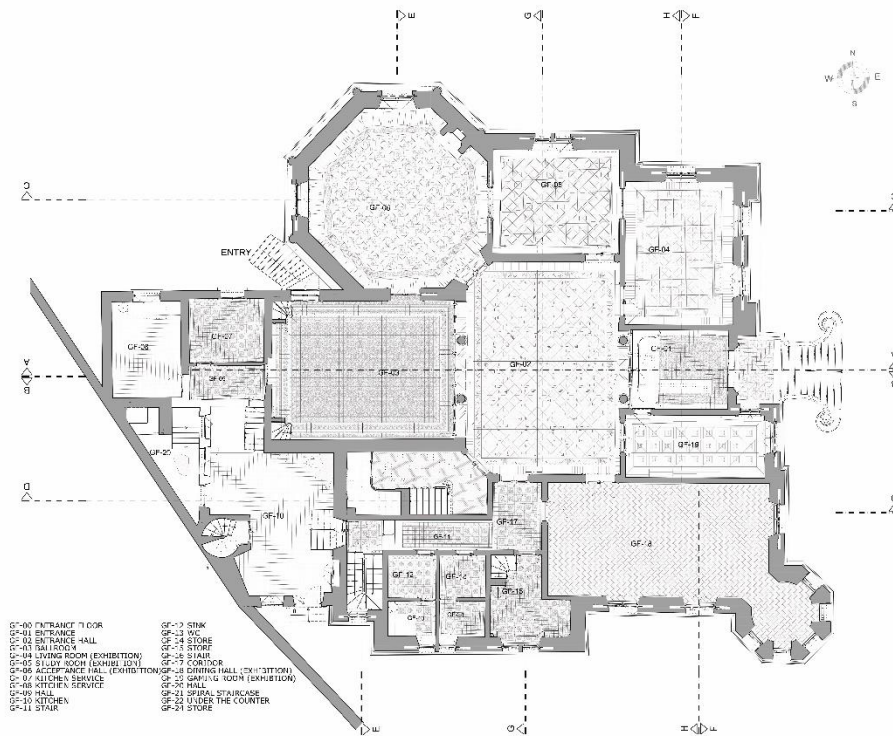
**Figure 6:** Ground floor, floor covering plan (Measured drawings) (Kuleli, 2013).

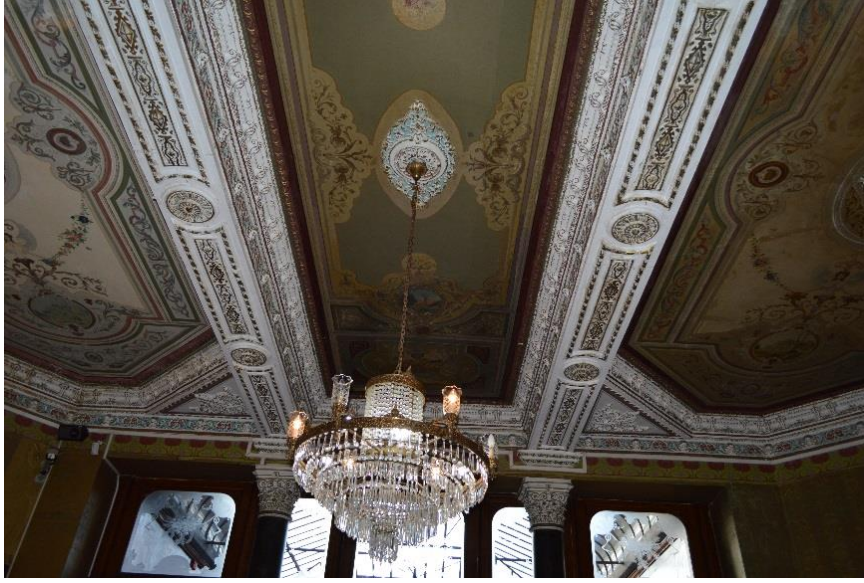
**Figure 7:** Decoration program of entrance hall GF-02 (Kuleli, 2013).

Original examples of the decoration program of the building such as granite columns, glasses decorated with sandblasting technique, silk wallpapers, plaster ornaments, mural paintings, tile mosaics can be seen on the ground floor (Fig. 7).

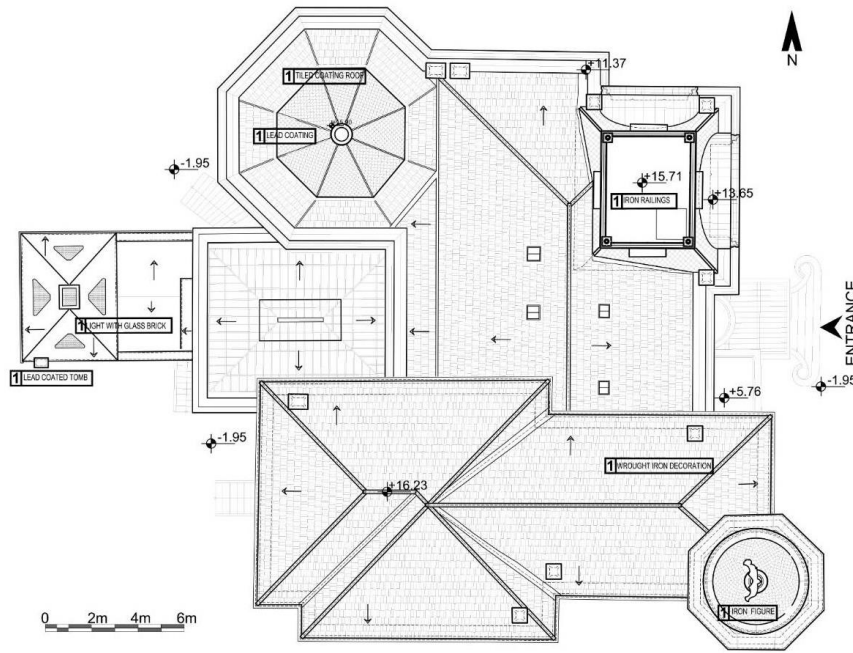
**Figure 9:** Roof plan (Restitution- First Period) (Kuleli, 2013).

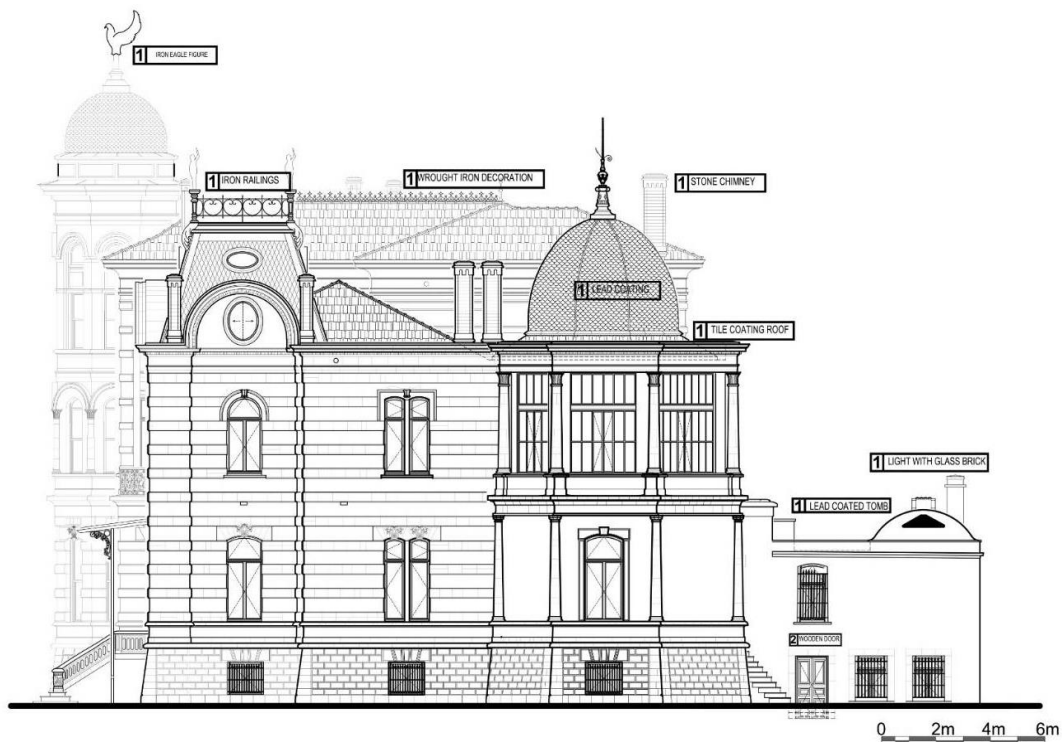
**Figure 11:** North facade (Restitution- First Period) (Kuleli, 2013).

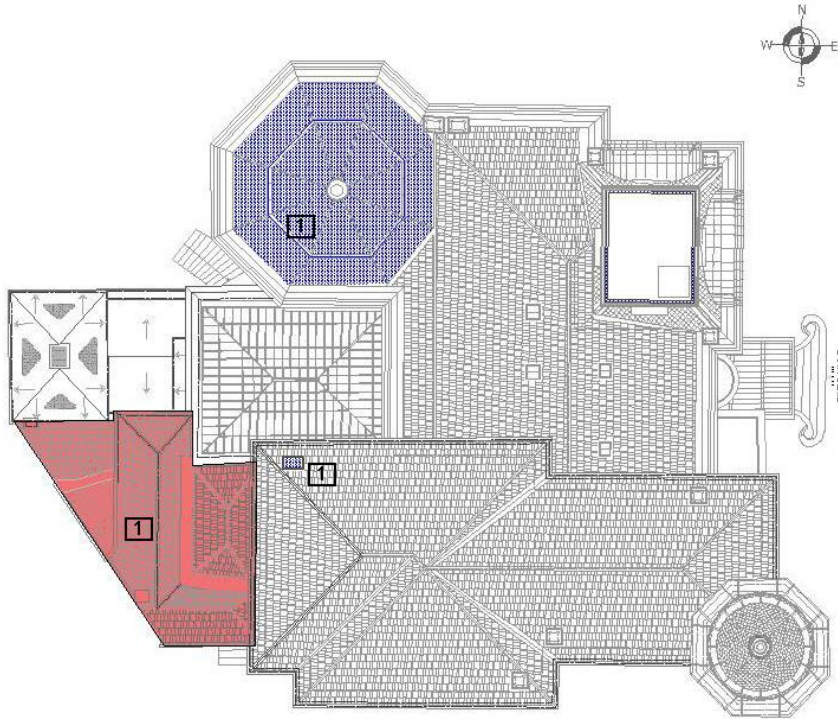
Using the sources obtained, the added items are marked in blue, and the changed items are marked in red in the drawings (Fig. 12).

- The courtyard area was converted into GF-10 and GF-20 coded spaces as an annex and covered with a roof during the repair.
- GF- 14 was divided into two rooms.
- Fish scale leaded roof coating of 1F-12 coded room's dome was changed with a plain lead coating.
- It is seen that the iron eagle figure on the dome covering the 2F-04 in the old photographs was removed during this period. Iron ridge decoration was also removed in this period.
- The garden, originally covered with stone, was coated with cast mosaic.

**Figure 12:** Roof plan (Restitution- Second Period) (Kuleli, 2013).

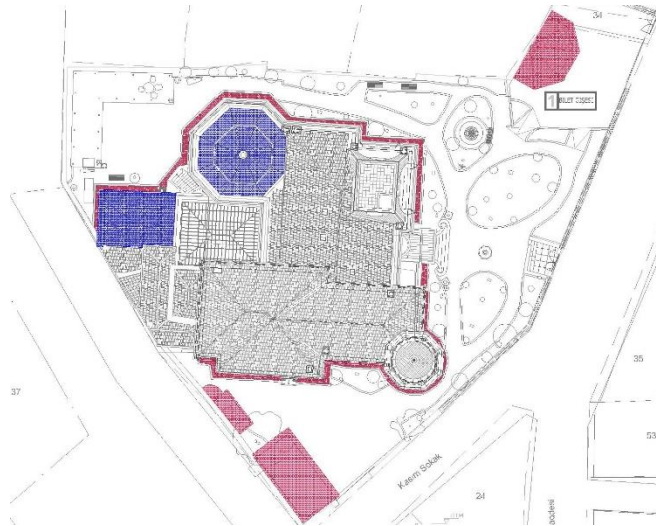
- The original vault covering the GF-07 coded kitchen space located in the west of the building, was probably removed at the end of the second period or at the beginning of the third period.
- While repairing the building, the original brick vault and iron beams of the ceiling were covered with the suspended ceiling on the basement floor. On the other hand, the original ceiling system in BF-04, BF-05, BF-09, BF-10, BF-11, and BF-17 were not hidden with suspended material.

- The toilet, a water tank, and a ticket office were built as annex buildings.

**Figure 13:** Site plan (Measured drawings- Third Period) (Kuleli, 2013).

### ***Third Period: 1987 & 2001- Today (Fig. 13)***

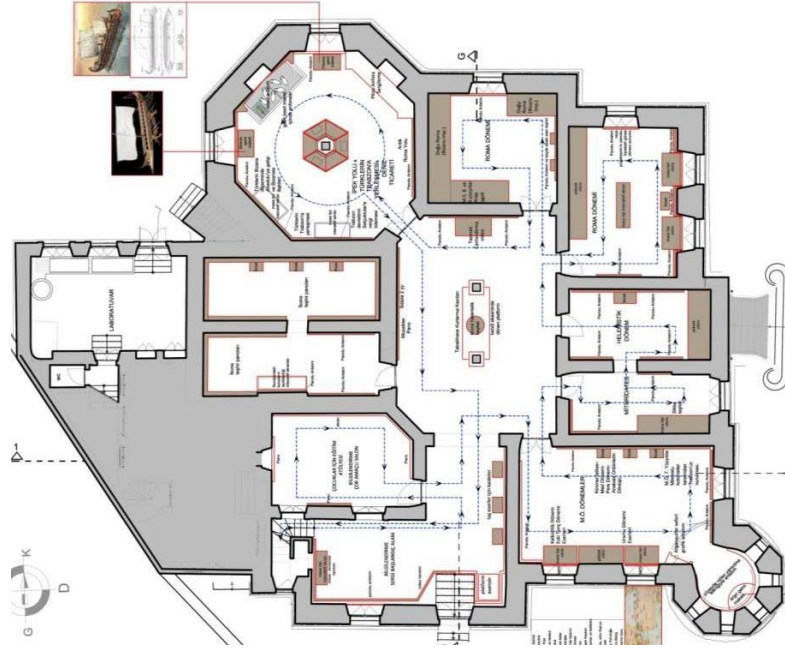
The exhibition route will be started on the basement floor (Fig. 20). On this floor, it will be available to visit the exhibition of archaeological and ethnographic objects (Fig. 21). Besides, functions such as education atelier for children and conference hall are located.

**Figure 20:** Exhibition concept and visitor route in the basement floor (Kuleli, 2013).

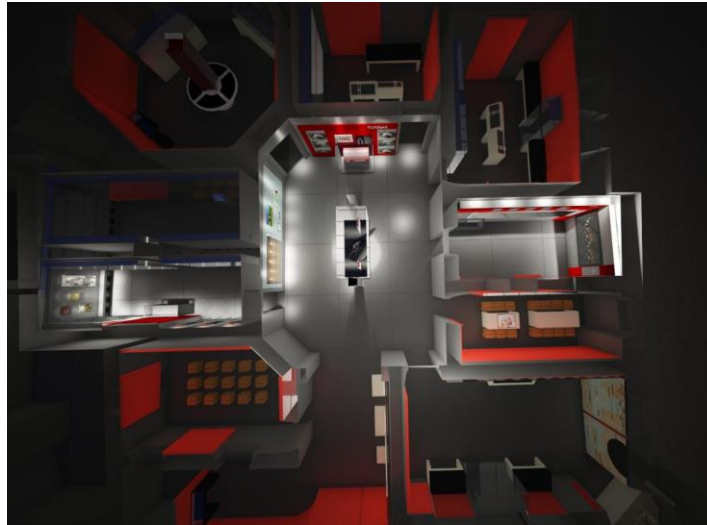
**Figure 21:** Exhibition concept - 3D model (Kuleli, 2013).

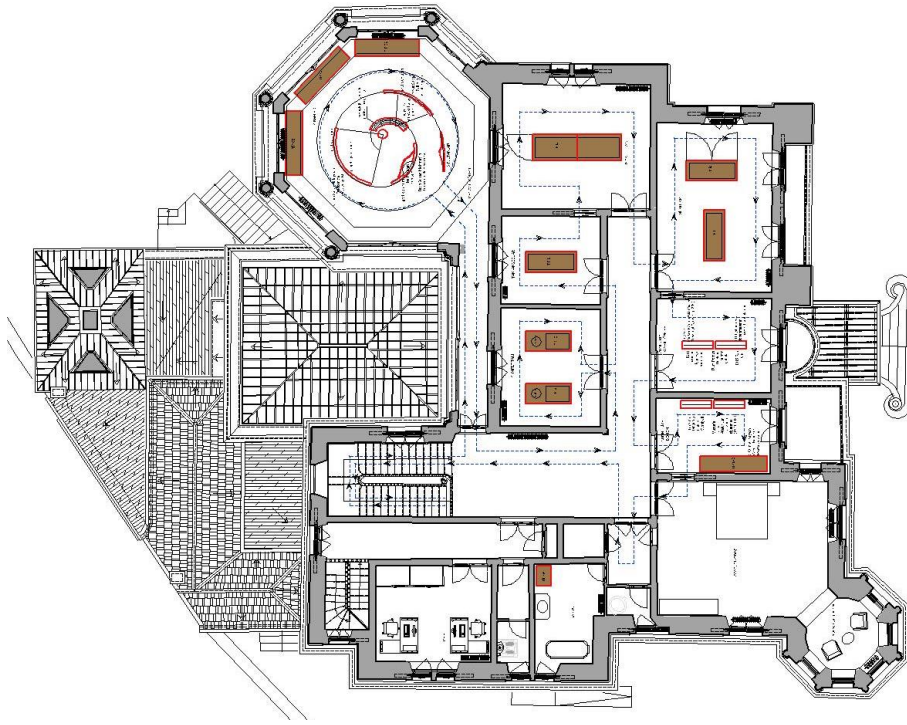
On the first floor, the exhibition route will be started with clothing, jewelry, and accessories used in the Ottoman Period (Fig. 24, 25). Then the itinerary will be continued with the Pre-Republic and Republic Period and the Chamber of Atatürk Exhibition. On this floor of the museum, it is envisaged to display exquisite examples of Ottoman weaving and embroidery, traditional man and woman clothing of the Ottoman era, accessories, and jewelry.

**Figure 24:** Exhibition concept and visitor route on First Floor (Kuleli, 2013).

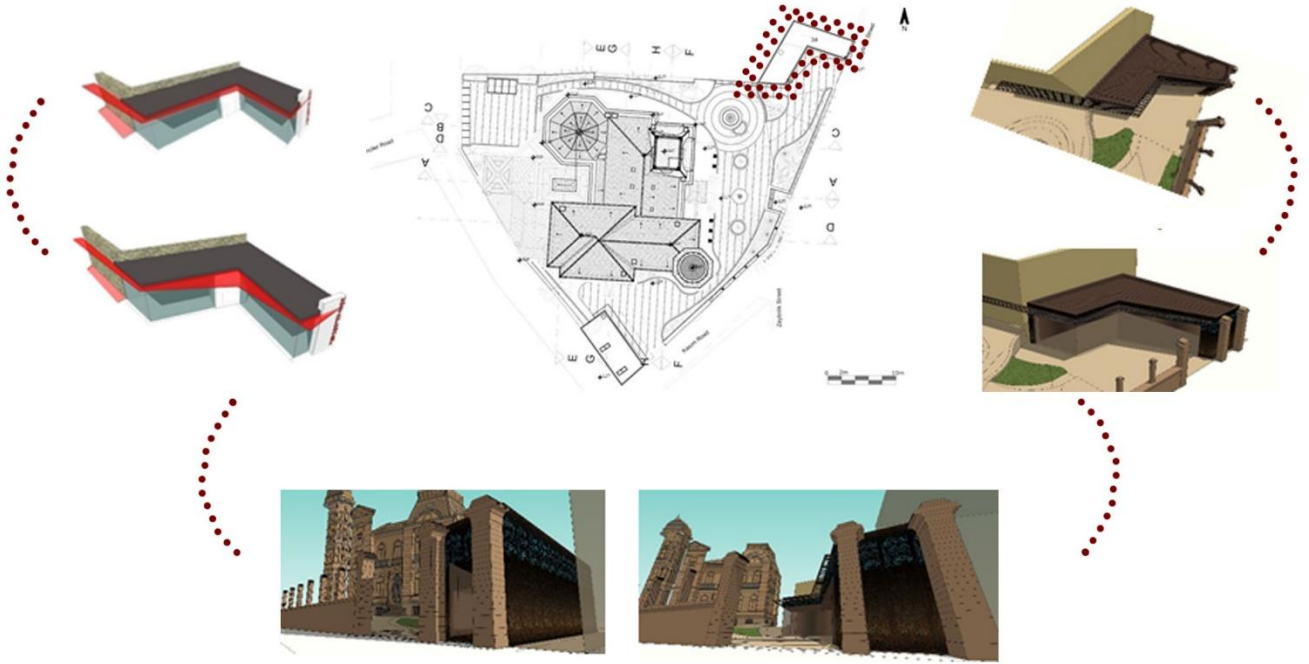
It is thought that it is appropriate to locate the annex building close to the garden entrance (Fig. 26). It is suggested to remove the existing ticket office located in the southeast corner of the courtyard and to build a new one with a basement floor in the same location. Considering the application data taken from the Trabzon Cadastre Directorate, the building is positioned to rest on the parcel boundaries in the southeast direction. While determining the form of the building, it is aimed to strengthen the orientation of the visitors to the Kostaki Mansion.

**Figure 26:** Location and appearance of annex building / 3d sketch drawings (Kuleli, 2013).

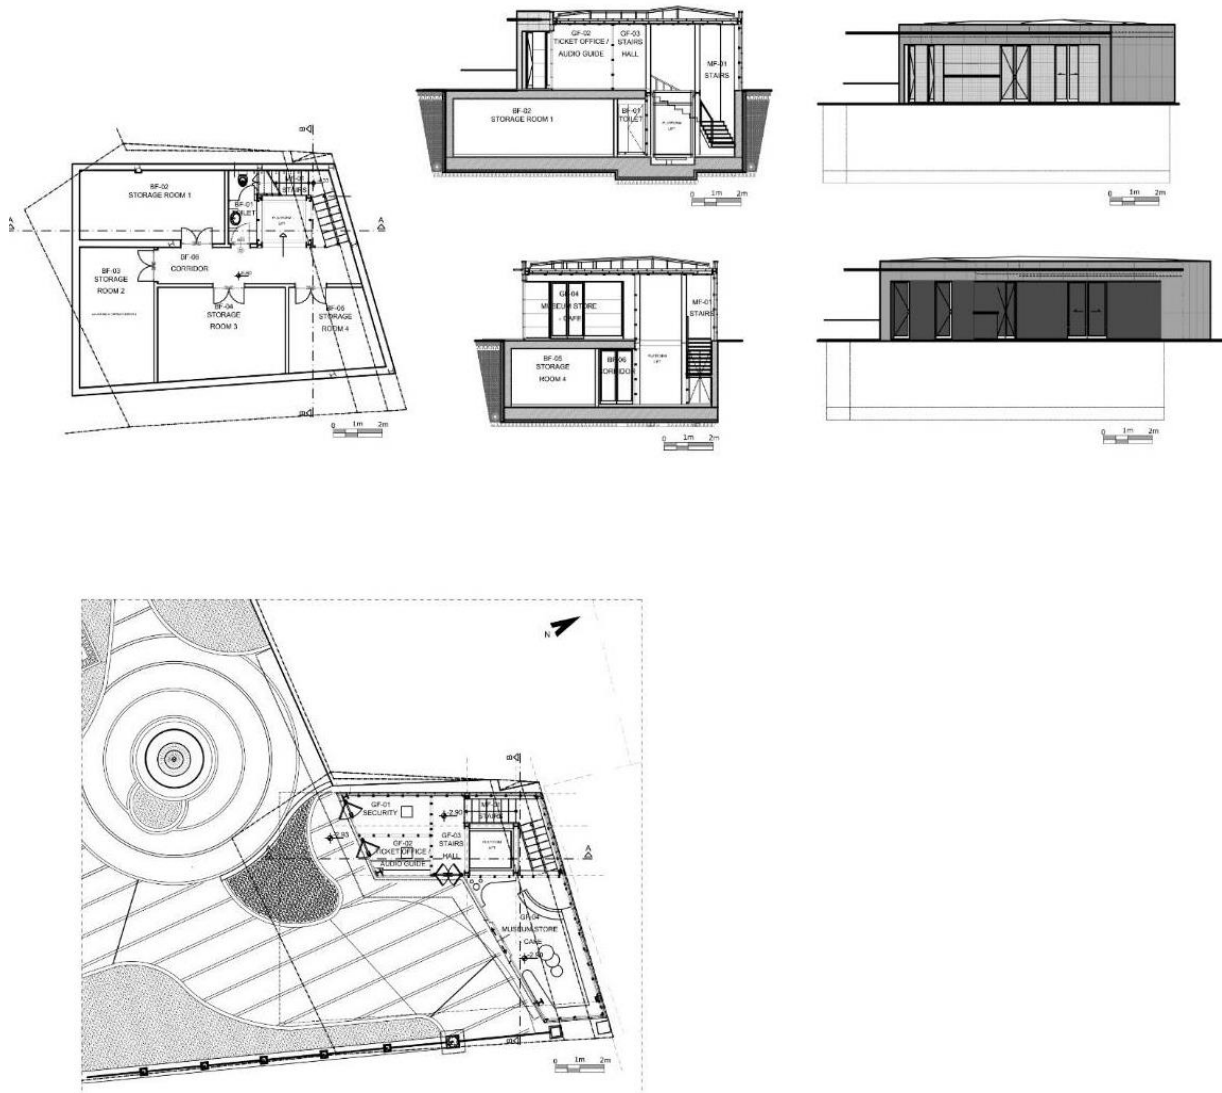
The building, designed to be of reinforced concrete and steel construction, has 112 m<sup>2</sup> on the basement floor and 59 m<sup>2</sup> on the ground floor. There is a ticket office, security office, audio guidance, museum shop on the ground floor, and storage takes place for the museum on the basement floor.

In the structural system selection of the building, it was preferred to use reinforced concrete on the basement floor and steel construction on the ground floor, by keeping in mind the necessity of requiring minimum infrastructure work around the historical building during the implementation process. The exterior facades of the structures, which are constructed with carrier steel profiles, will be covered with corten (rusted) semi-permeable (perforated) steel panels. The steel canopy element continues parallel to the courtyard wall in the east-west direction.

**Figure 27:** Annex building proposal's details (Kuleli, 2013).
