Documentation Studies and Material Researches of Ramazan Semseddin Mosque in Ankara

Ayşe Esin KULELİ¹, Latif ÖZEN²

In this study, some part of documentation studies of Ramazan Şemseddin Mosque, its conservation problems, material researches and results of the analysis are presented.

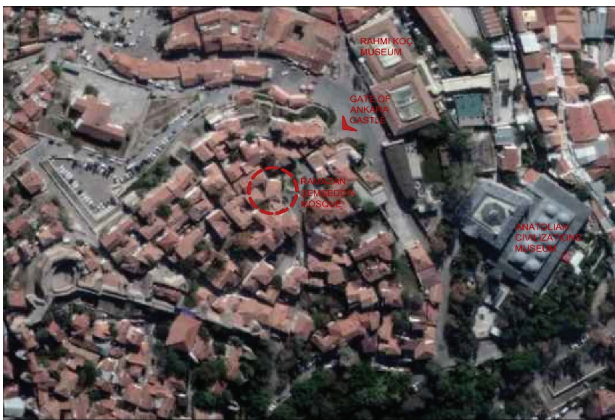
Figure 1. The location of the mosque and the entrance of the castle.

The triangular-shaped entrance section was added to the east side of the building. This space hasn't any historical value in terms of materials and design. A double-winged door leads to the original part of the mosque. In the right and left sides of this door, there are sets about 40 cm high, covered with wood, while the floor of the entrance hole, covered with modern tiles. The dimensions of the harim, which is the main gathering place of the mosque, are approximately 7.25 m x 7.75 m and the floor is covered with wood and carpet. The walls and wooden ceiling are plastered and painted in white. In the center of the ceiling, there is a wooden hexagonal shaped and profiled core which is painted brown color. There are gilded leaf motifs which are oriented to four sides inside the core.

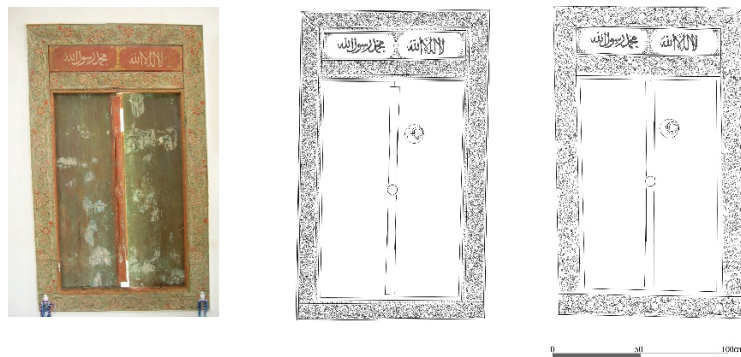
Figure 5. Decoration of the windows on the eastern wall (Detail no: 2, 3).

In the east wall, carnations, pomegranate flowers, and hatayi motifs are observed in the frames of the windows, while the southern wall windows have rose blossom, pomegranate flower, and leaf motifs. Motifs are dominated by red and green colors. Kelime-i tevhid "Lâ ilâhe illallah Muhammedün resûlullah" from the Koran is written on the top part of all windows.

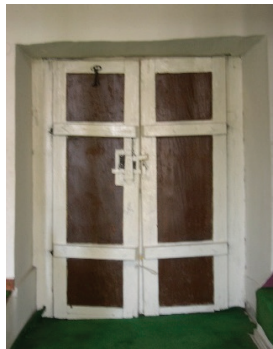
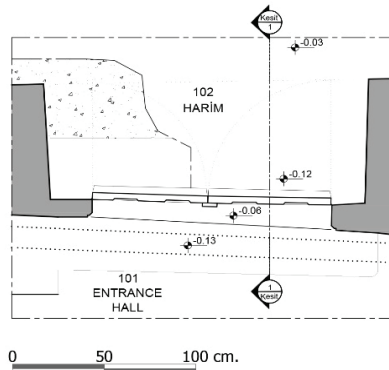
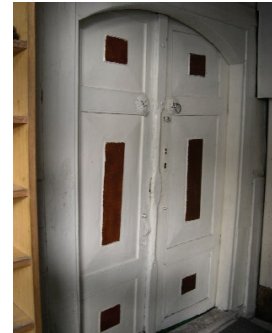
Figure 6. Detail of the entrance door (Detail no: 1)

The door which provides entrance to the harim is arched and the door sill is made of stone. Wooden door wings have three-table and are painted in white and brown. The door is mounted to the frame with ring-shaped interlocking hinges.

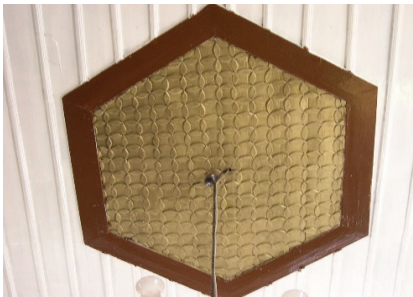
Figure 7. Ceiling decoration.

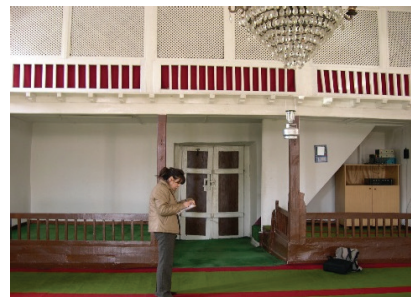
Figure 8. View of the north wall of the Harim.

The women section is located in the north direction of the harim and is carried by four wooden posts. There is a wooden staircase on the east side of the entrance, adjacent to the north wall to reach to the women section. The gallery overlooking the harim has plain wooden railings. There is also a gate to the minaret on the northeast corner of the place.

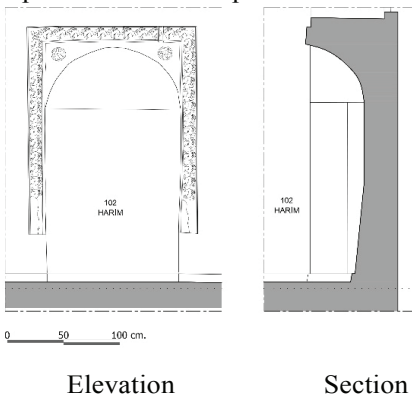
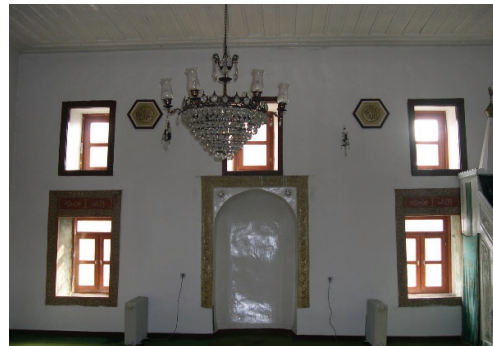
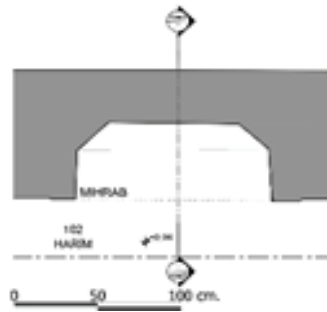
Figure 11. View of the south wall of the Harim

Figure 12. Mihrab detail (Detail no: 5)

The rounded arched mihrab in the qibla wall was decorated with herbal-style embossed motifs and painted with gilding paint. The side panels of the minbar were made of wood in a rectangular shape. The same arrangement can be seen on the side surfaces of the kiosk. The kiosk has a pointed cone on top of it.

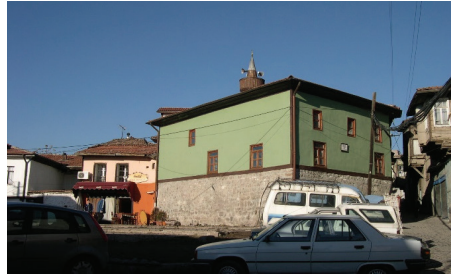
Figure 14. South and east elevation

The mosque hasn't the last prayer hall. On the eastern facade, the left and right corners of the original walls are chamfered. The windows are located on two different levels, as bottom and top. The rubble stone wall at the bottom of the facade was grouted using cement.

A corner of the southern facade is orthogonal, but the other corner is chamfered. There are 2 windows in the lower part and 3 windows in the upper part and these windows have the same characteristics as the windows on the east and west facades. The western facade of the building has 2 windows at the upper part and 1 window at the bottom part.

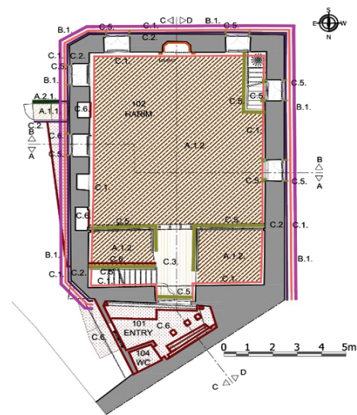
Figure 15. Deterioration analysis legend
Figure 16. +1.20 level plan

The damages detected during the fieldwork were transferred to the analytical drawings using the 'Mapping Method' in the office. Each problem and damage was indicated by hatching in a different color and these hatches were identified by a legend. Thus, it was aimed to identify similar and different problems in various parts of the structure.

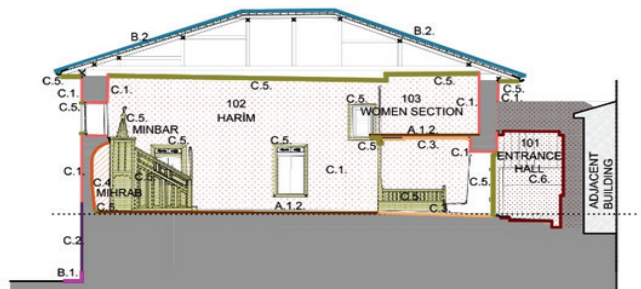
Figure 17. A- A section.
Figure 18. D- D section.

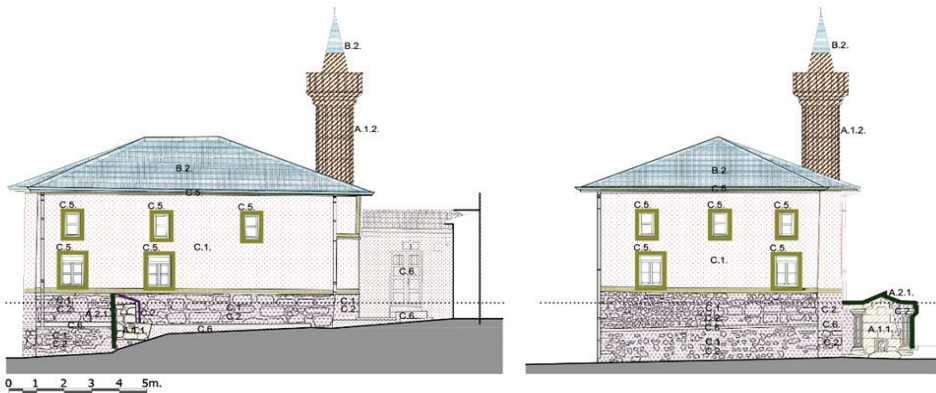
Figure 19. South elevation

Figure 20. East elevation

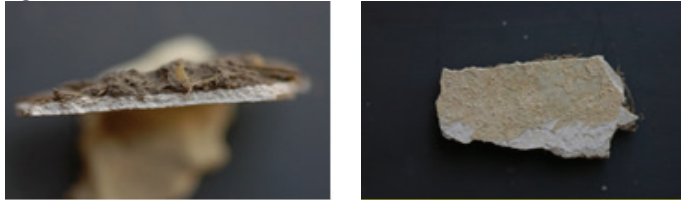
Figure 21. The appearance of mud plaster and painted layer on lime plaster

Figure 22. Close-up view of the lime plaster

When the plaster sample is examined under the stereomicroscope, a layer of mud plaster is seen on the mud brick and two layers of lime plaster are seen on it. The outermost plaster is thinner than the other. The paint on the surface of the plaster is silicone-based and it is thought that the paint may have been used during repairs.

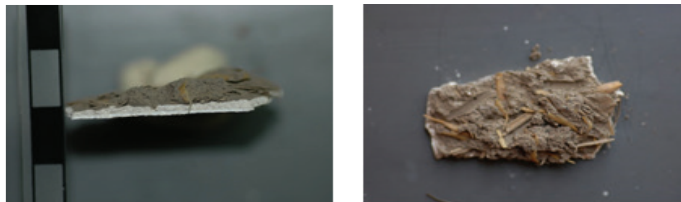
Figure 23. Scaled photo of mud plaster and lime plaster as two layers

Figure 24. The appearance of mud plaster

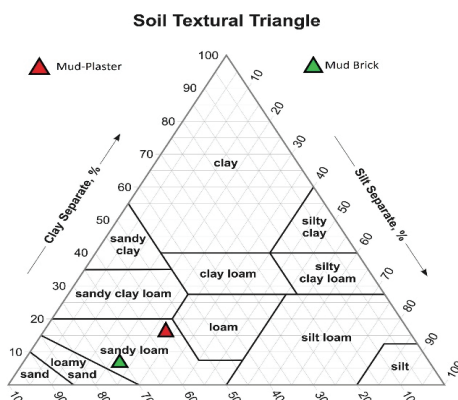
Table 2. Texture Triangle Diagram of Samples.

According to the triangle diagram, the samples both mud brick and mud plaster are in the area of "SANDY LOAM".

It is recommended to use soil containing values as the mixture of 76% Sand, 14% Silt (Loam), Clay 10% for the production of mud brick. Also, since the mud brick contains approximately 9% organic material found in the analyzes, it is recommended to add 9% organic material (straw) into the mortar during the new mud brick production.

Likewise, for producing mud plaster, it is proposed to use 53% Sand, 29% Silt and 18% Clay. Additionally, since it is determined that the plaster material contained about 12.6% organic material in the analyzes, it is recommended to add 13% organic material (straw) into the mortar during the new mud plaster production.

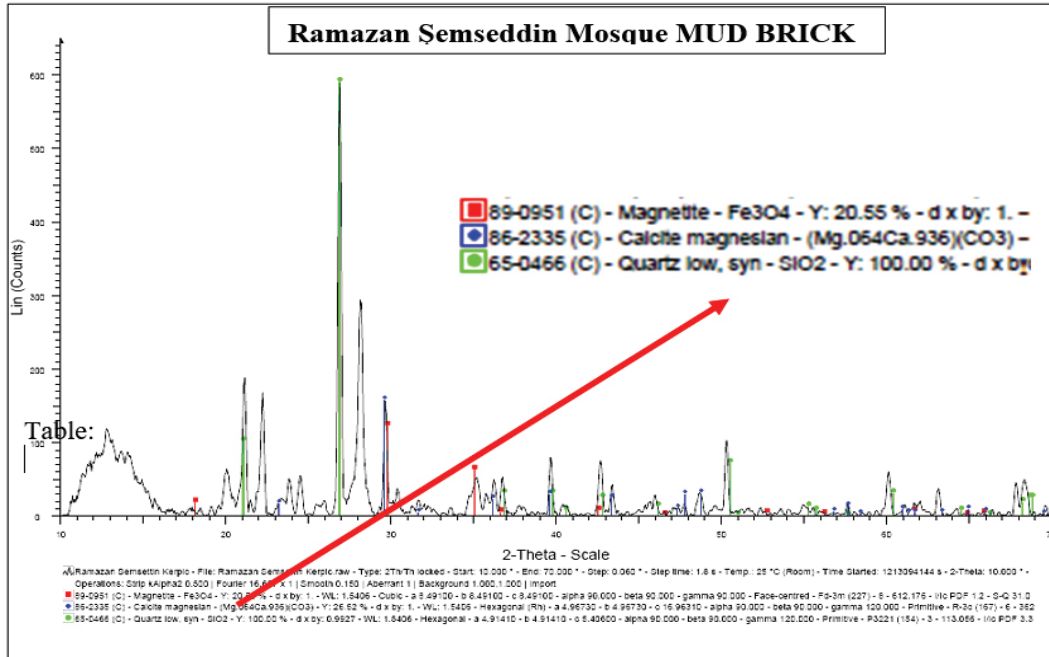
Table 3. XRD Result of Mud Brick sample.

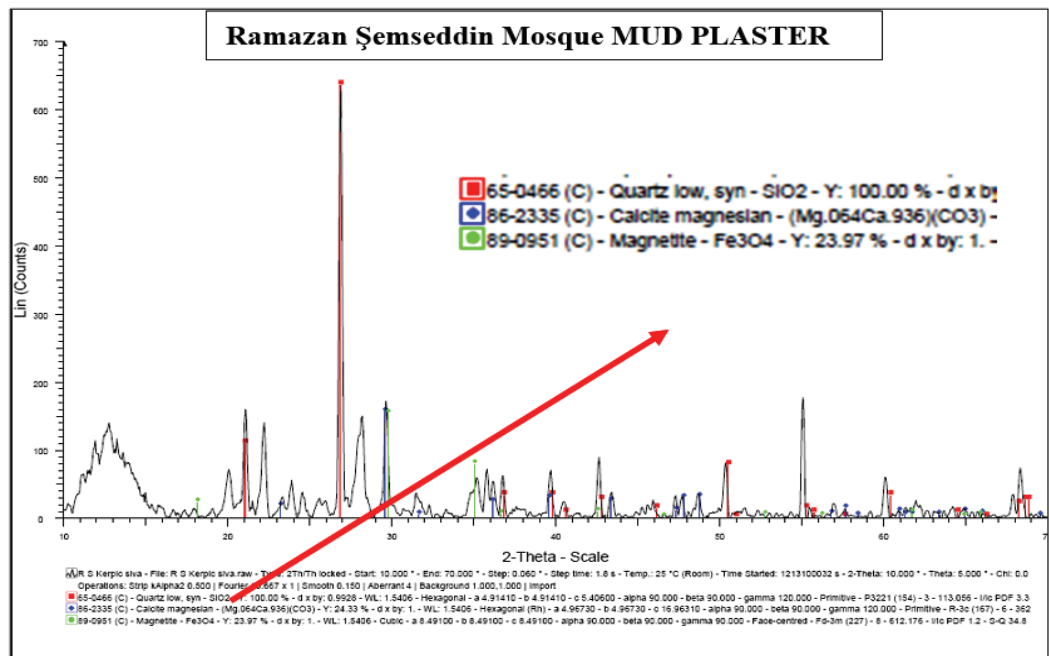
Table 4. XRD Result of Mud Plaster Sample.

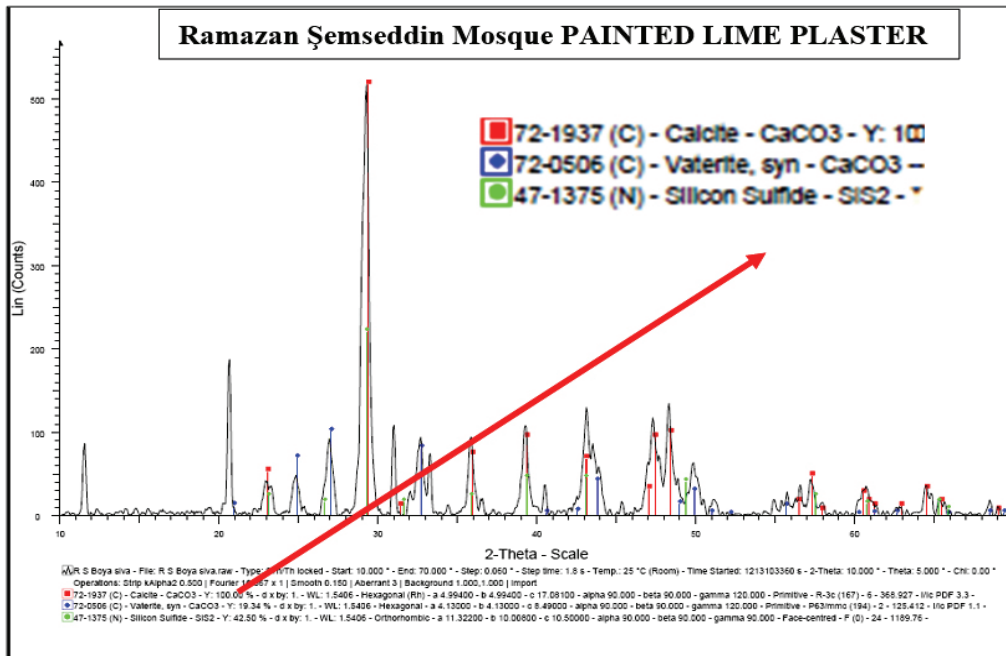
Table 5. XRD Result of Painted Lime Plaster Sample.

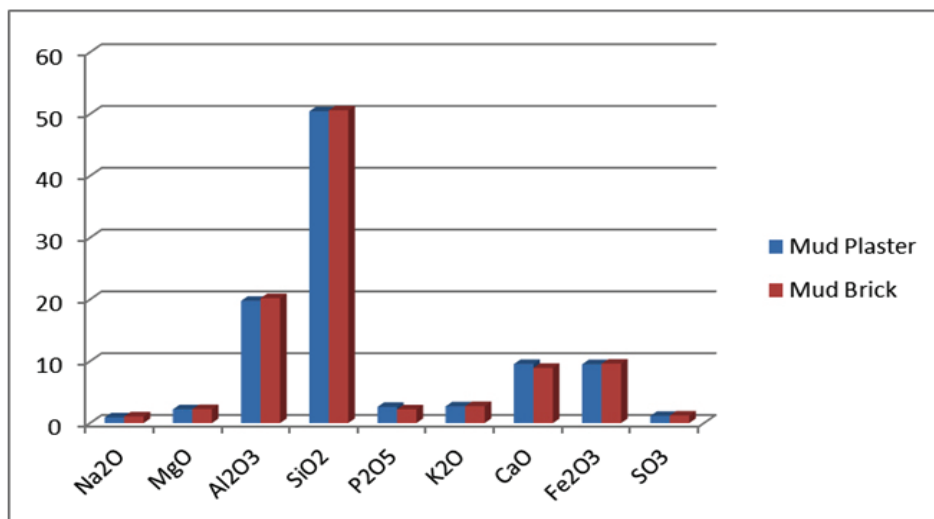
When the samples taken from the Ramazan Şemseddin Mosque are examined, it is thought that the same type of soil may have been used in the production of adobe and adobe plaster since the XRF analysis results contain similar values.

Table 6. Comparison Graph of the XRF Results on Mud Brick and Mud Plaster samples

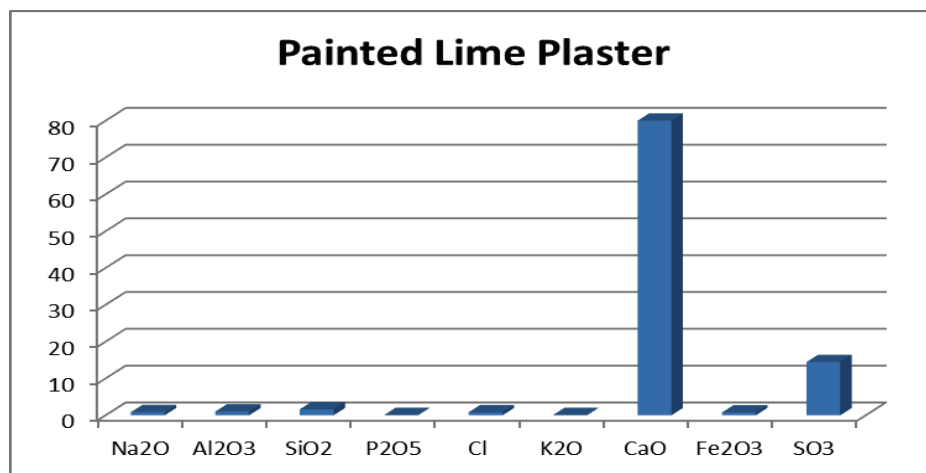
Table 7. XRF Result Graph of Painted Lime Plaster.
