Determination of the Deterioration Characteristics of Facade Materials: A Case Study

Nil Kokulu

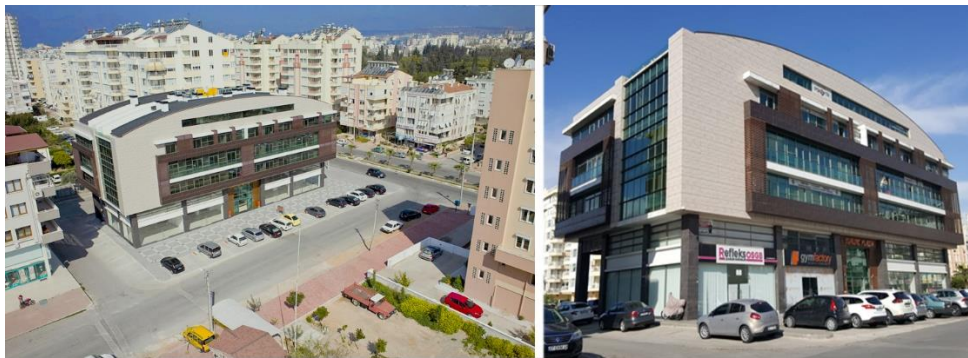
Figure 2. East facade of the building.

The building is located on the intersected corner of Portakal Çiçeği street and 1460 street in Antalya, Turkey. It is a seven storey-high residential building on the right with a distance of 8.40 meters, ten storey-high residential building on the back with a distance of 14 meters and front with a distance of 40 meters and two storey-car parking on the southwest with a distance of 21.5 meters. The main entrance faces to east (Figure 2). This facade always takes the sun directly without having any shading areas. The temperature and the light play a crucial role on materials. 1460 street and Portakal Çiçeği street have intense traffic. This causes air pollution which may create deterioration. The distance from the sea is 1 km and the height of the building from the sea is 22.5 m. The pedestrian roads and the vegetation around the building can be seen in Figure 3. There is an open area in front of the main facade. There are also car parking areas on the east and the west facade.

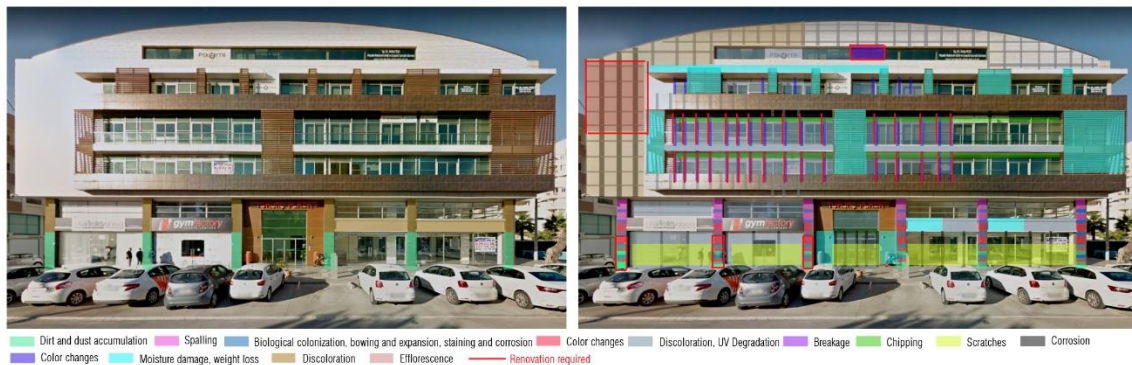
Figure 5. Facade of the building (on the left), facade of the building in 30 years (on the right).

In this study, visual observations have been made to determine the future deteriorations. Since the building is only three years old, only the dirt deposition and the discoloration on the surface of the granites and discoloration on the WPC's caused by the rain have been observed. Expected deteriorations of the materials are discussed below.

The panels would be affected by the temperature. It is clearly seen that no expansion joint was used, either vertical or horizontal. This may cause cracks and/or breakage even falling of the panels. Corrosion may occur on the metal structural supports and anchors of ceramic tiles (Campante and Paschoal, 2002). The panel joints may easily take water and air inside of the structure. Color changes create visually improper aesthetic that can be seen on the ceramic tiles (Song and Lim, 2016). The reason of this can be dirt deposition which comes with the wind. Biological agents may use wood as a food source or for living with the help of water intake from the cracks or joints. This may cause weight loss of the panel (Morrell *et al.*, 2010). The WPC's on the east facade can easily take water from the rain. It is clearly seen that air pollution

came with the rain and created a color change at the surface. Because of the absorption characteristics of the WPC's moisture may cause damage of the material especially on the shading areas (Morrell *et al.*, 2010). The lower parts of the wood composite look better than the upper parts. It is probable that the upper parts would have a mechanical degradation in the future. Especially in the summer, the sun plays an important role. Wood absorbs the UV lights. This causes loss of surface quality and change in the mechanical properties. UV degradation would be seen at the WPC's especially on the unshaded areas in the future.

The method presented in this paper was developed as a tool for the prediction of the service life of building components. Deteriorations have been analyzed by a systematic approach using environmental analysis, visual observations and literature review. It is clearly seen that, deteriorations on the facade of the building will occur in the future (Figure 5).
